TECHNICAL TIPS

ON THE SUNBEAM TIGER

JUNE 1980

TIGER FRONT CROSSMEMBER

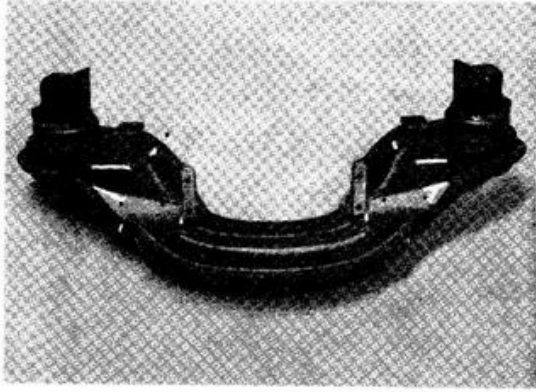
The attached photo series was taken during the examination and repair of Bruce's crossmember. Figures 1, 2, and 3 show the extensive cracking found in high stress areas. These cracks are highlighted for the camera with $\frac{1}{4}$ " wide white tape. As you can see, the cracks were located either at welds or at a sharp bend in the metal. This suggests that the local residual stress from welding and bending, play an important role in the fatigue failure of this assembly and are the most important areas to examine to spot the beginnings of this type of failure.

Figure 1 Cracks on the top half

The sheetmetal stampings making up the crossmember are relatively thin and normal metallic arc welding will probably result in burn thru unless the welder is very careful. I always get my best result by TIG welding the sheetmetal stampings and metallic arc welding the thicker shocktowers. I strongly recommend this method. It's also a very good idea to clean off the grease and grime and properly clean and prep the weld area by removing all traces of weld slag, paint, etc.

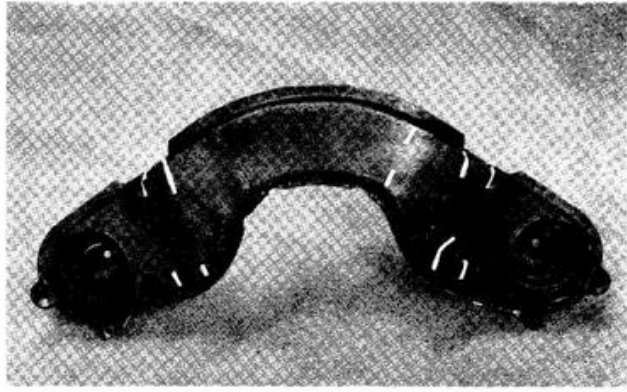
Figure 2 Cracks on the bottom half

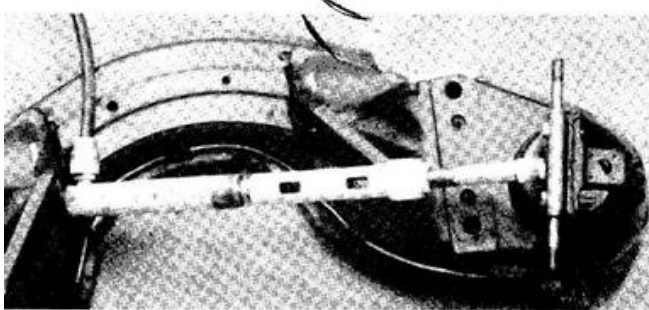
Figure 4 Hydraulic ram application

Figure 4, below, shows the best method I have found to return the shocktowers to their correct location and at the same time, to remove most of the fatigue bending in the crossmember itself. A length of threaded rod, nuts, and a strip of 3/4" or thicker plywood, wide enough to span the spring opening, can be used to apply a downward force to the shocktower during the bending operation. The rod protrudes through a hole in the center of the plywood and nuts top and bottom are tightened to pull the assembly into the correct position.

The base of the steering rack support is used to hold one end of the hydraulic ram while the other end pushes against the upper A-arm fulcrum pin, or suitable replacement. This avoids bending the back of the shocktower. I recommend getting the towers back into position tack welding them, and reinforcing them as shown, before attempting to apply the pressure necessary to spread the shocktowers to the correct specification.

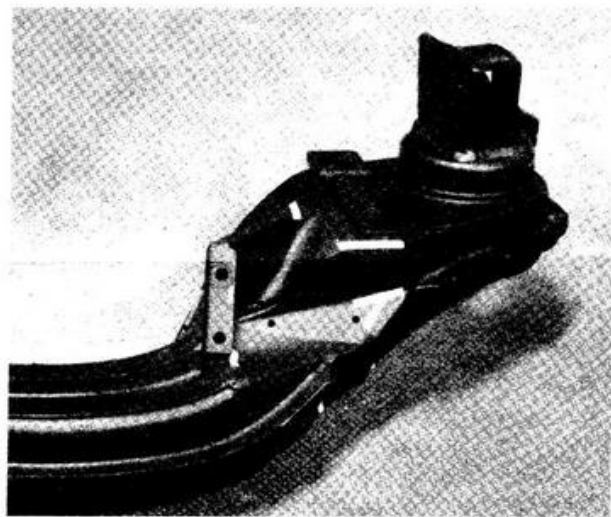
Figure 3 Closeup of crack locations

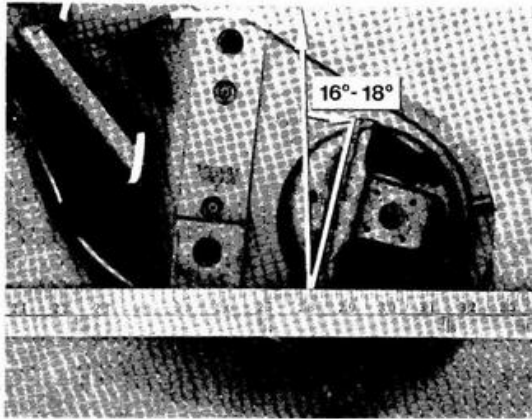
I have found that the closest distance between the rear corners of the shocktowers should be 28" to 28 ³/₁₆", and that the intercept angle of the shocktower and the upper A-arm should be 16° to 18° from straight ahead. Figure 5 is the best I could do to demonstrate this data. Since there is nothing in the area that is flat, straight or helpful, these angle measurements are very difficult. I think that if you can get it close to the numbers given above, the shimming process will allow the correct wheel alignment to be obtained.

Figure 5 Shocktower measurements

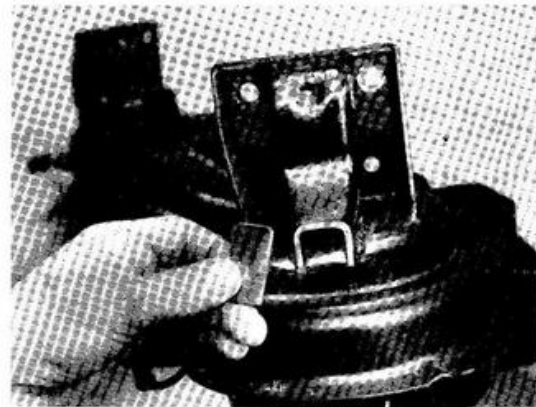
Figure 6 1/8" snubber insert

Figures 6 and 7 show the 1/8" thick steel insert which is placed in the open end of the snubber stop. This piece is vital, as it prevents the first crack which always occurs in the side of the snubber stop. Without it, you will be lucky to prevent future failures. After this insert is installed, you should apply a good fillet weld on the three sides of the shocktower at the spring dome. If you can weld the crack (or there is none) in the side of the snubber stop, do so; otherwise you should fabricate a small 1/8" plate to spread the load down to the spring dome. Figure 8 shows the completed job ready for painting and reassembly.

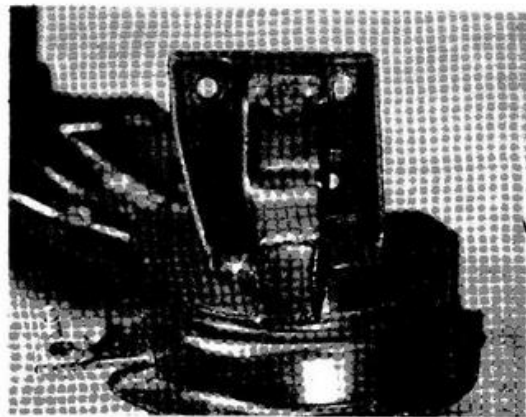
Figure 7 Insert welded inplace

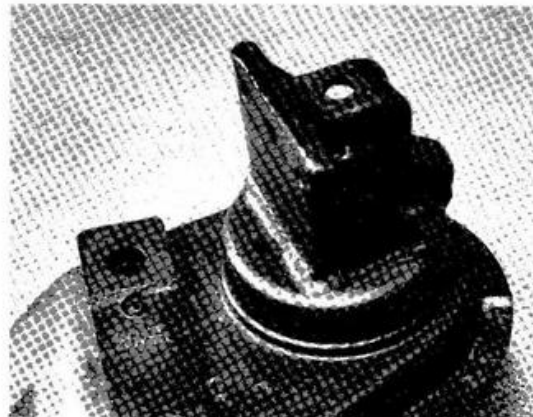
Figure 8 Completed reinforcement job
